**National Statement on CW
Issues:
Measures against the Potential
Hazard of OCWs in Japan**

15 May 2007

Gen'ichiro TSUKADA
Ministry of the Environment (MOE)
Government of Japan

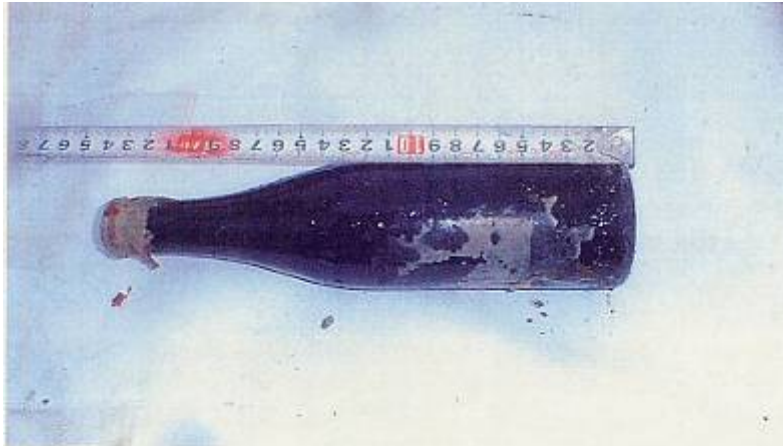
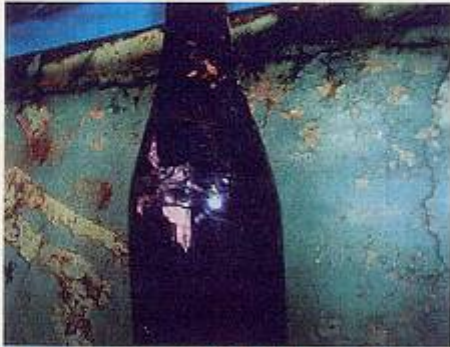
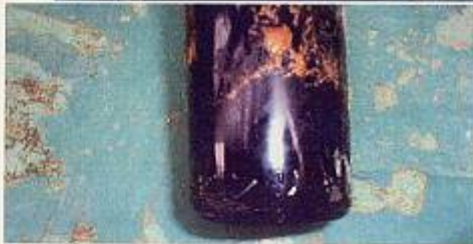
Dug-out beer bottle

- The number of bottles found : 806
- Content of bottles :
Mustard / Lewisite
(Yellow Agent)

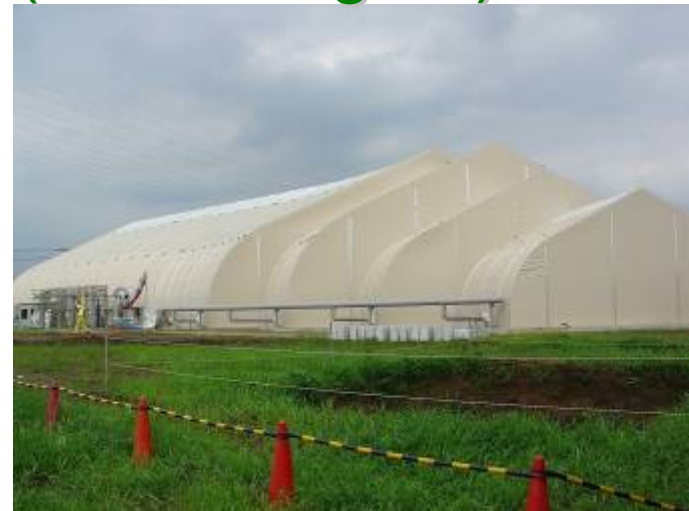
Dug-out soils were covered to prevent spreading.

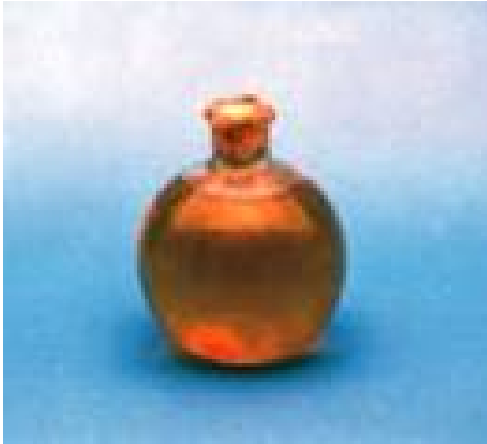
Dug-out round glass bottle which contains
Hydrogen Cyanide
(Brown Agent)

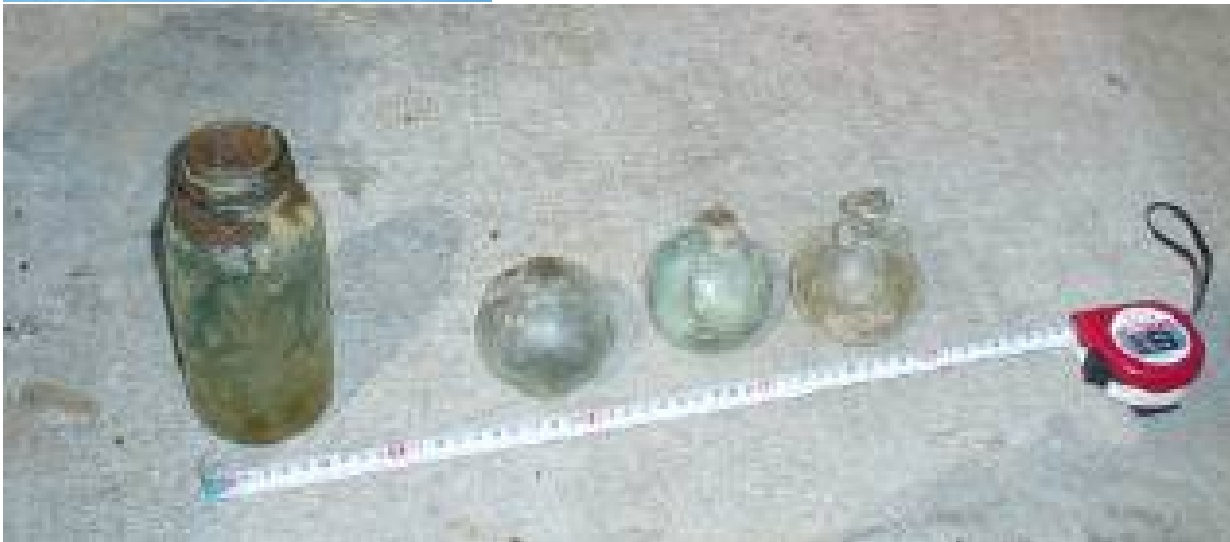
There was either white powder, clear fluid or soil in glass bottles.

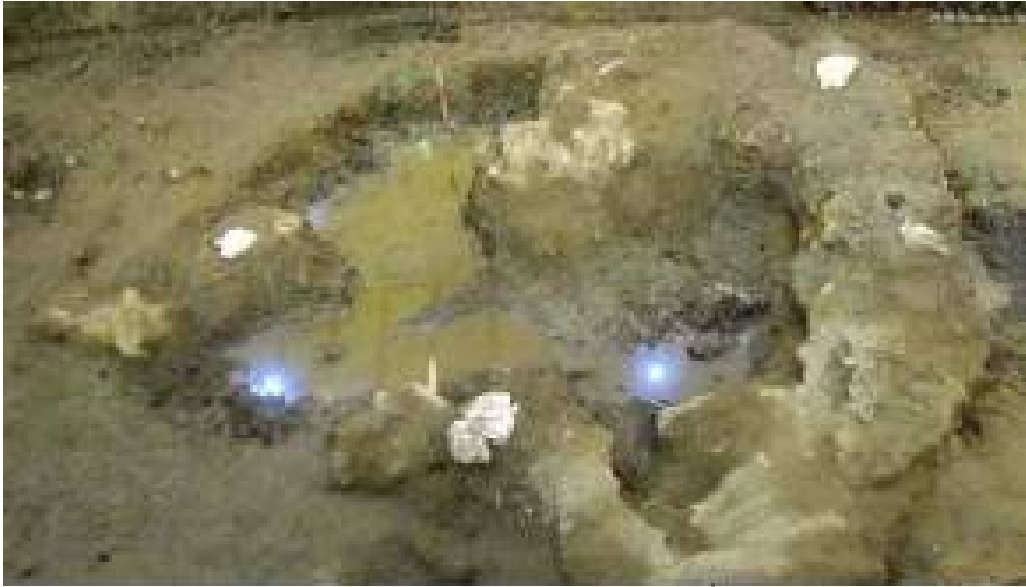
A solidified cement mass
mixed with DPAA

- 87 tons of solidified cement masses including DPAA were discovered in 2005.
- It is likely to be a cause of the groundwater and soil contaminations.
- It is judged that they were dumped by someone in or after 1993.

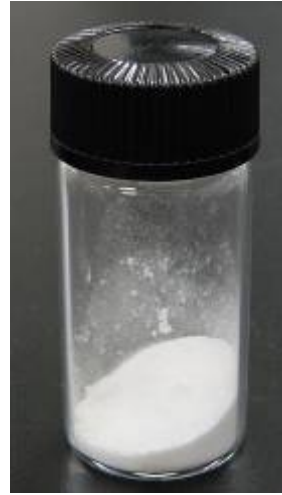
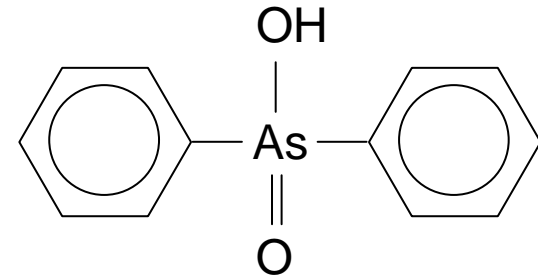
Diphenylarsinic Acid
(DPAA)

- **DPAA is an artificial organoarsenic.**
- **It could be a precursor of diphenylchloroarsine (DA/Clark II) or diphenylcyanoarsine (DC/Clark I).**

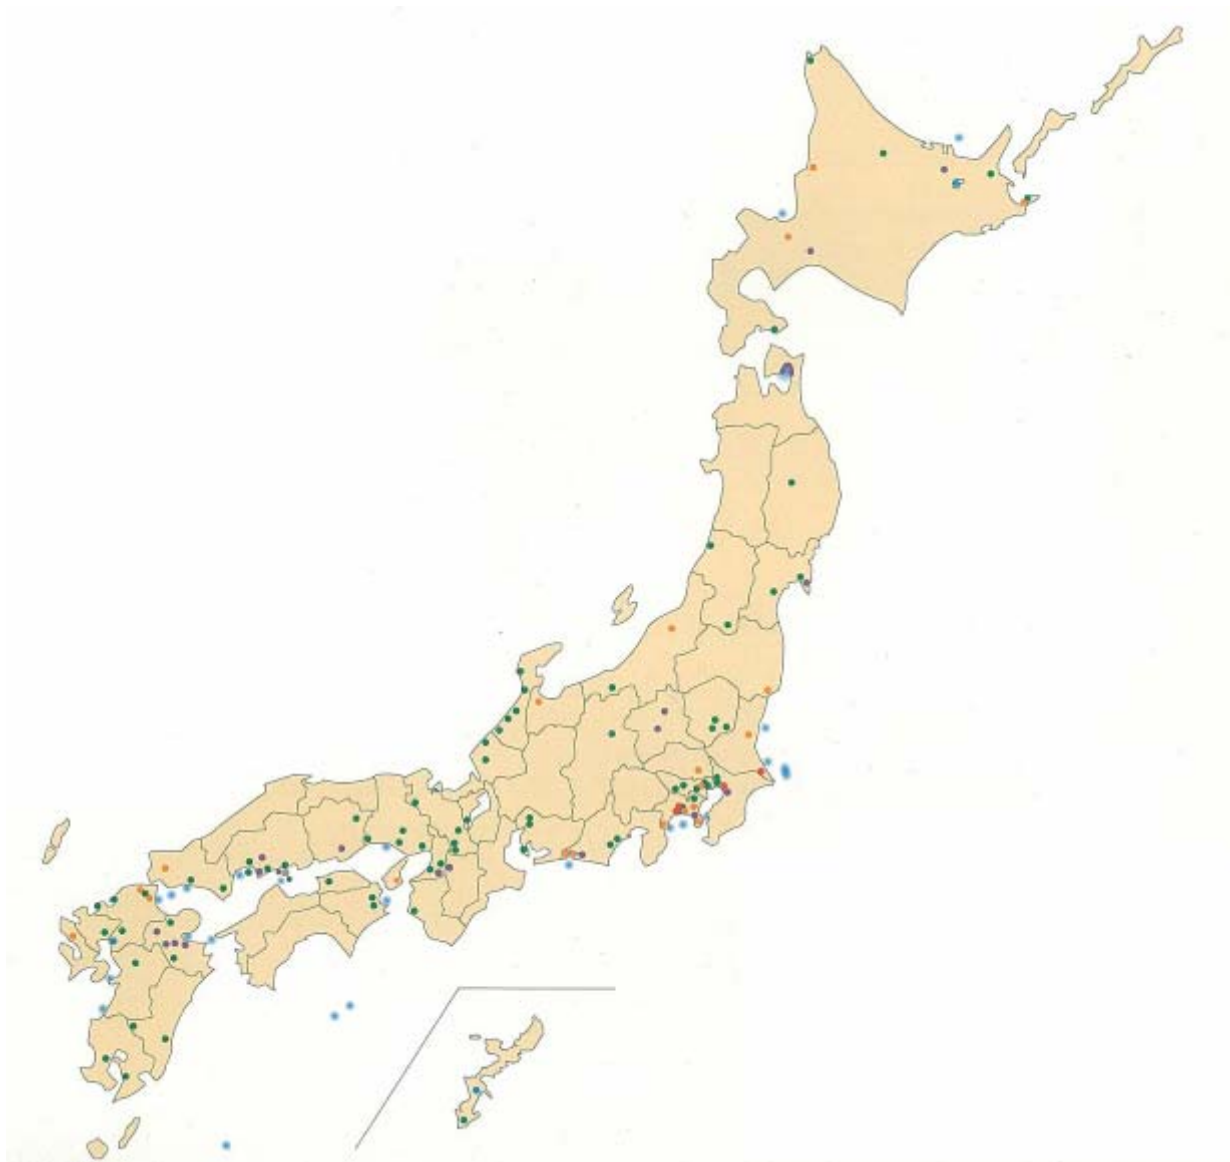
Locations of 138 survey sites

Category	
On Land	● : A
	● : B
	● : C
	● : D
● : in water

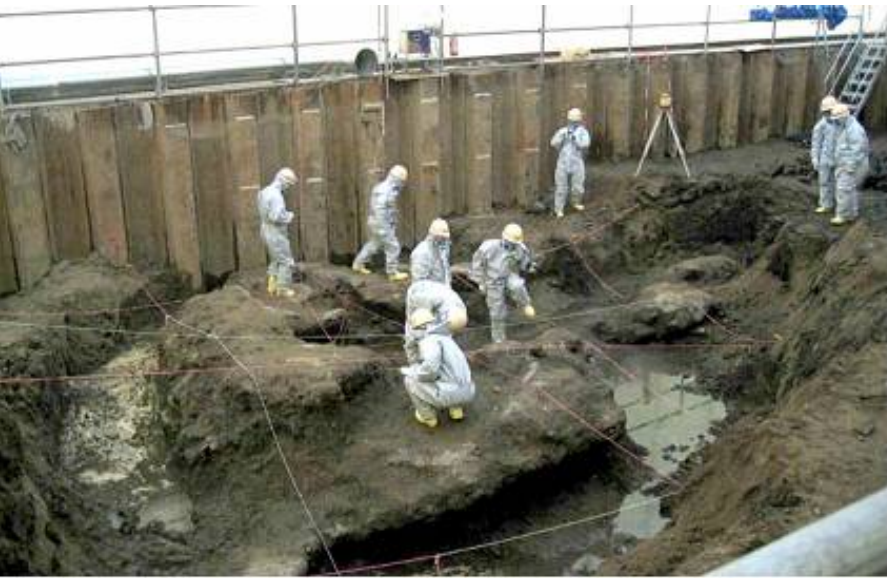
Operation in Kamisu City

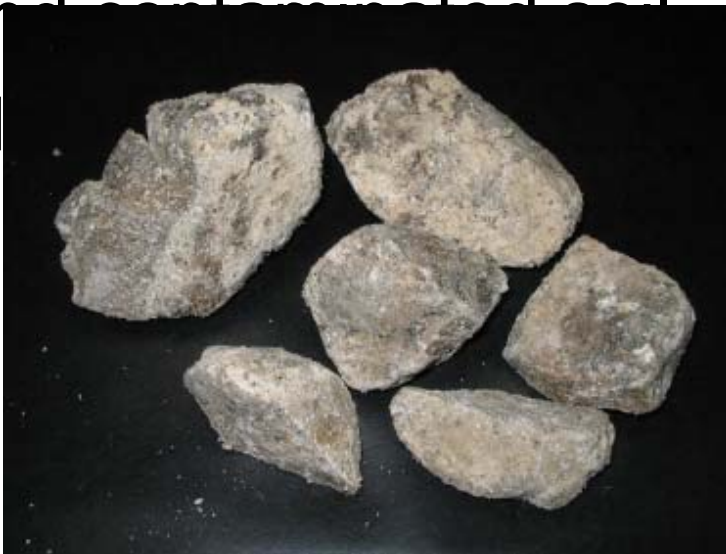
- Found suspicious white blocks from the ground
- The blocks were identified as phenylarsine oxide (PAO) which is thought to be a precursor of DA and DC.
- Now preparing to remove and treat these blocks and the contaminated soil

Phenylarsine Oxide
(PAO)

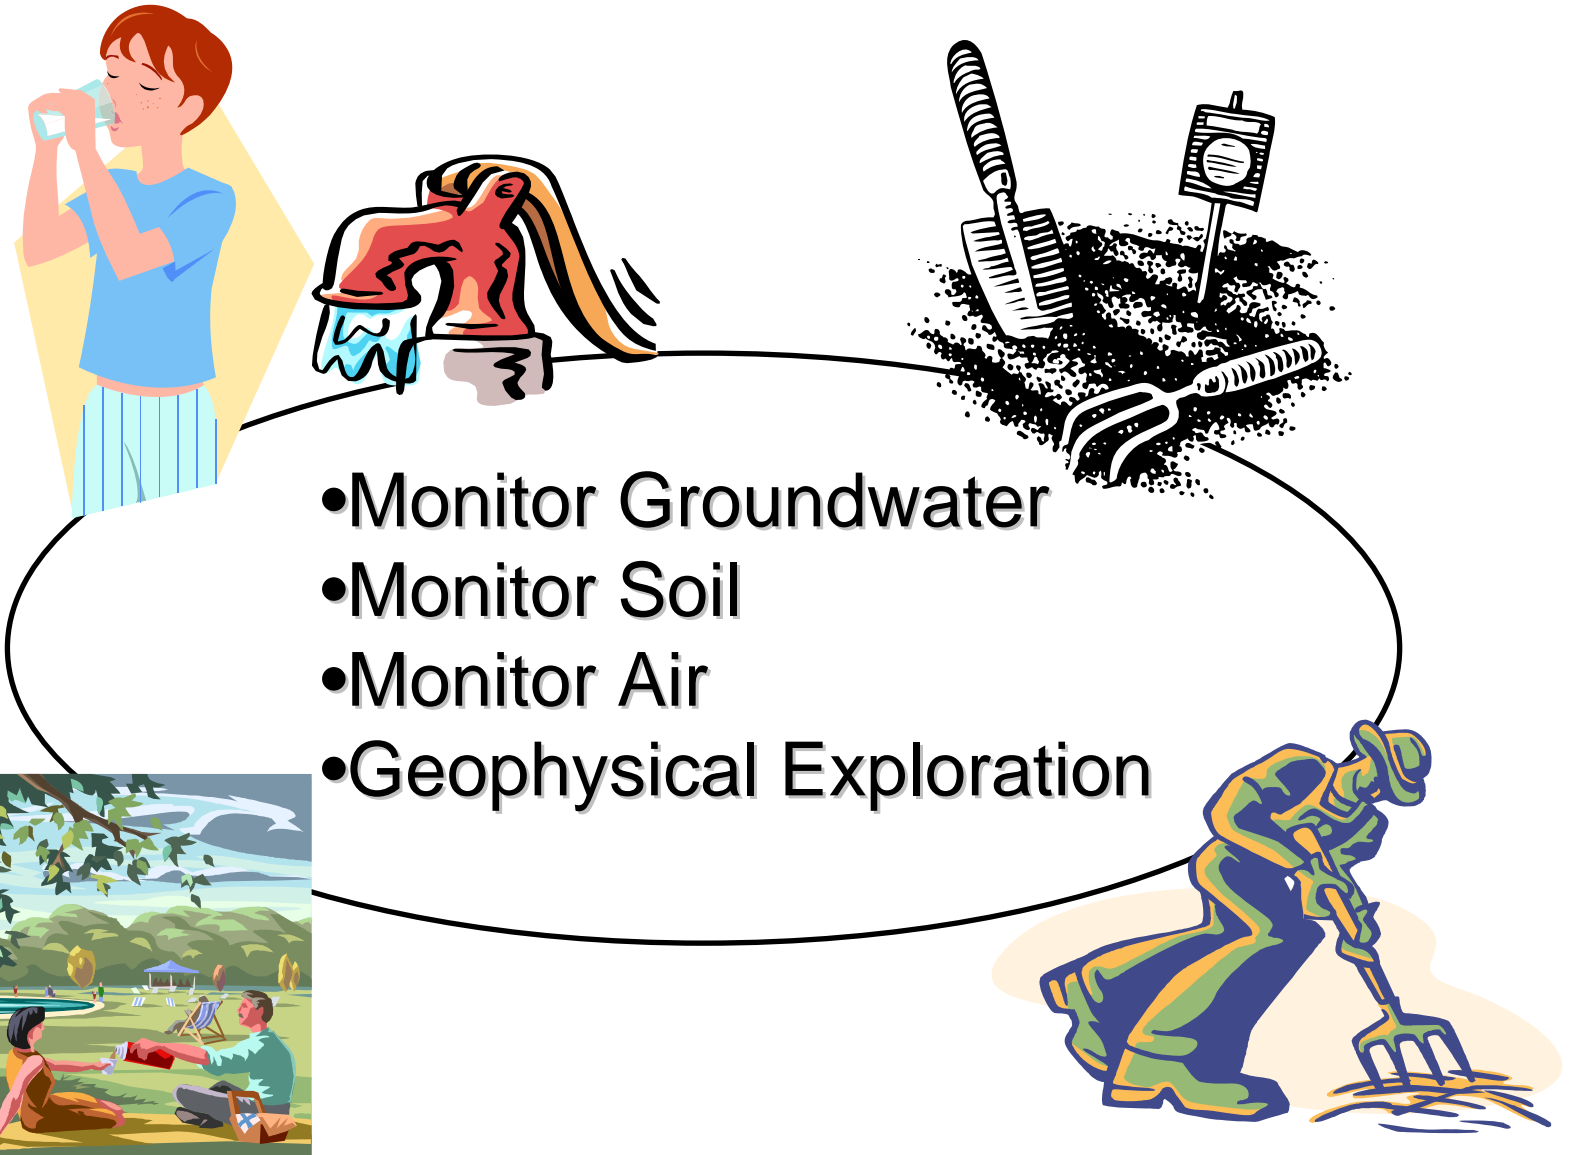
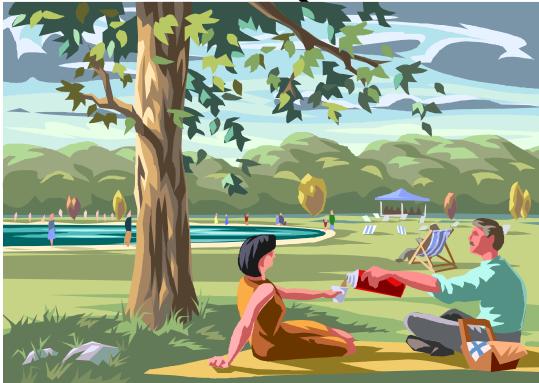
Methods of environmental investigation

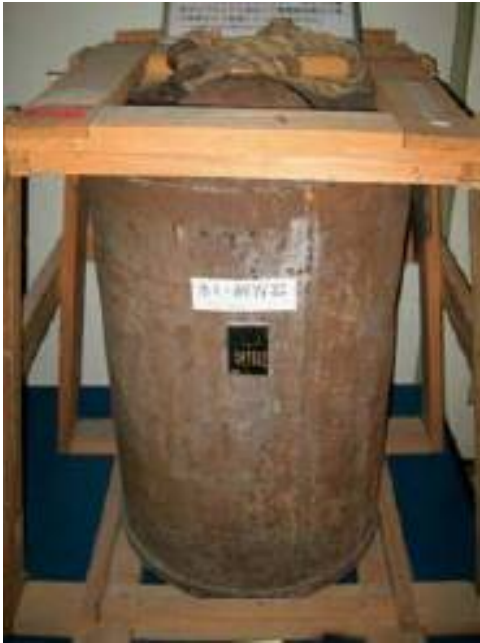
A chemical drum container

- A suspicious metal object was detected under the ground by geophysical exploration. This may be a chemical drum container manufactured by the Japanese Imperial Forces.
- Now preparing to dig the ground and confirm and treat the buried object
